Manhole Inspection Summary

Manhole # S37QQ_017MH

Insp Date: **1/16/07 11:17 AM**

Location Address: **2468 BRENTWOOD AVE**

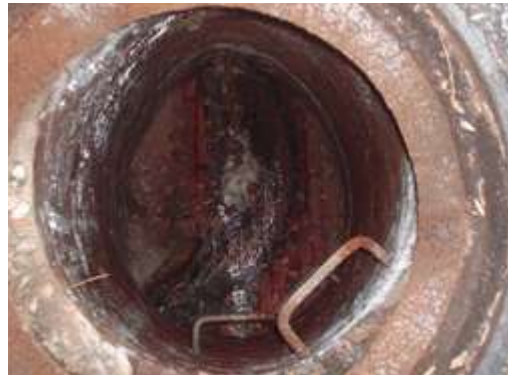
Top View

Condition: ☐ Sound ☐ Cracked ☐ Root Intrusion ☐ Deteriorated ☐ Leaks ☒ **Debris**

Steps Count: **3** Missing: **0** ☒ **Corroded**

Corroded steps. Channel debris.

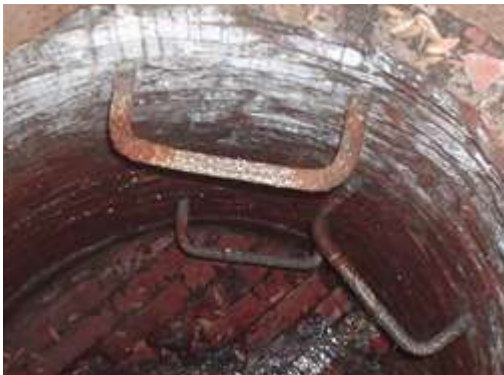
Defect

Frame Offset: **6** (in.) Condition: ☒ Sound ☐ Cracked ☐ Leaks

Condition: ☐ Sound ☐ Cracked ☐ Root Intrusion ☐ Loose Brick ☒ **Deteriorated**

Infiltration: ☐ None ☒ **Joint** ☐ Cracks ☐ Mortar ☐ Roots ☒ **Wall**

Infiltration: ☐ None ☐ Joint ☐ Cracks ☐ Mortar ☐ Roots ☒ **Wall**

Frame offset. Adjustment deterioration and infiltration. Barrel infiltration.

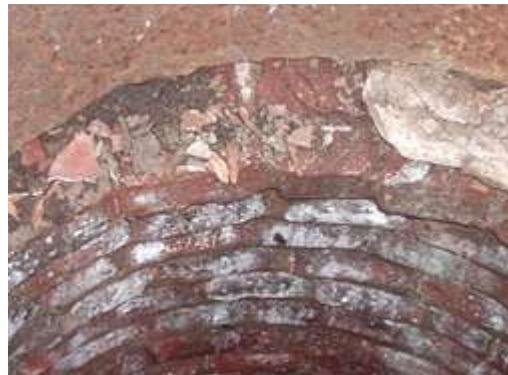
Defect

Frame offset. Adjustment deterioration and infiltration.

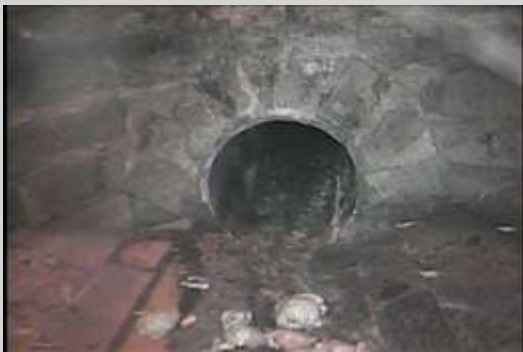
8 in. Circular Gravity Sewer Pipe Out @ 12 O'Clock

Deposits: ☐ None ☒ **Mud** ☐ Sludge ☐ Debris ☒ **Grease**

Silt Depth: **0** (in.) Deposits Extent: **Light**

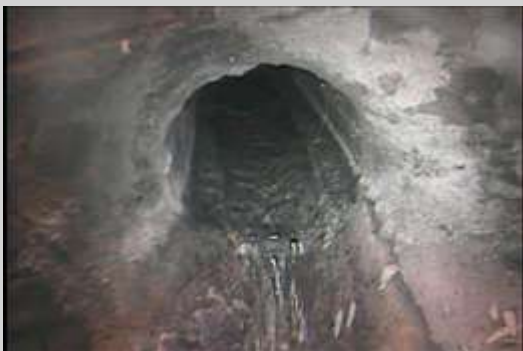
6 in. Circular Gravity Sewer Pipe In @ 7 O'Clock

Deposits: ☐ None ☐ Mud ☐ Sludge ☐ Debris ☒ **Grease**

Silt Depth: **0** (in.) Deposits Extent: **Light**
